TECH TIPS

SERVICE TIPS FOR THE AUTOMOTIVE TECHNICIAN

TAKING THE MYSTERY OUT OF SUBARU TIMING BELT REPLACEMENT

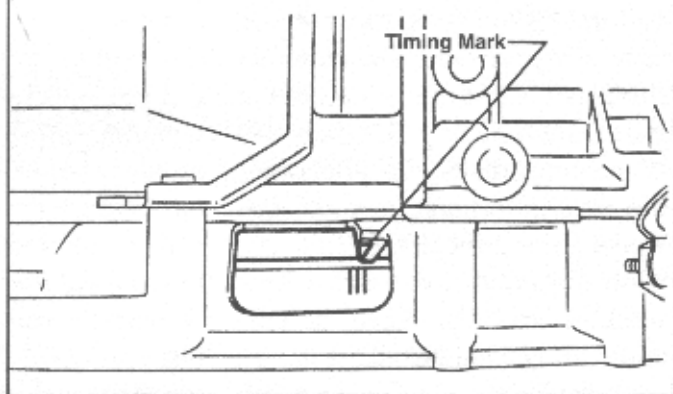
Diagram #1

At the flywheel end of the engine, there are two sets of timing marks. One set is used for the ignition timing and places the #1 cylinder at top dead center. The other set is the correct one to use for timing belt replacement. This consists of three lines closely spaced (refer to

diagram #1). In order to place the crankshaft in the proper position, the middle line of this set must be aligned with the timing pointer.

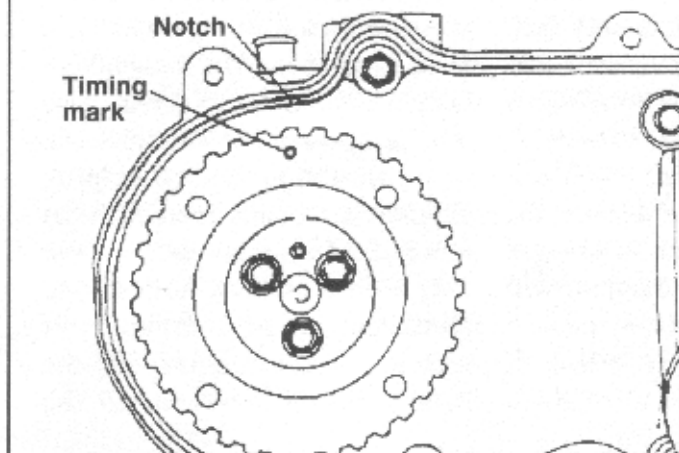
Diagram #2

This places the cams in a position so that they won't be affected by spring pressure and rotate out of position. Set the right bank cam to the 12 o'clock position (refer to diagram #2). Install the right-hand timing belt and tension as required. Before you install the left bank timing belt, rotate the crankshaft one full turn. At this point, the right cam timing mark will now be in the 6 o'clock position. Now, set the left bank cam timing mark to the 12 o'clock position (refer to diagram #3). Install the left belt and complete the job.

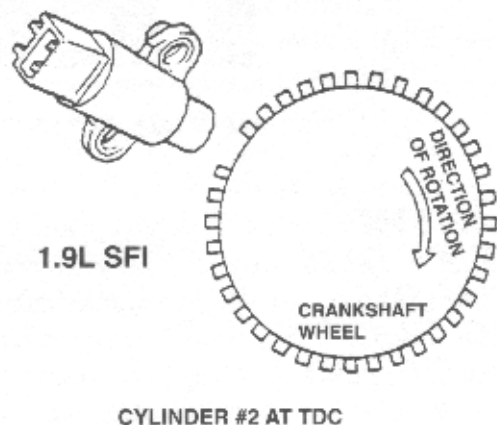
Diagram #4

If you get one of these vehicles that experiences a no start or a lack of power condition after someone replaced a broken accessory belt, check to see if the crankshaft trigger wheel is out of sync. When a belt breaks, sometimes it finds its way between the crank sensor and the trigger wheel. As a result, the trigger wheel, which is pressed onto the crankshaft damper, will rotate on the damper, just enough to create a no start or a lack of power condition due to retarded

base ignition timing. A quick way of verifying this is to bring the #2 cylinder to top dead center of the compression stroke. Now, check to see if the crankshaft position sensor is lined up with the missing tooth space of the trigger wheel (refer to diagram #4). If it is not, then you have found your problem. At this point do not attempt to repair the damper. It must be replaced.

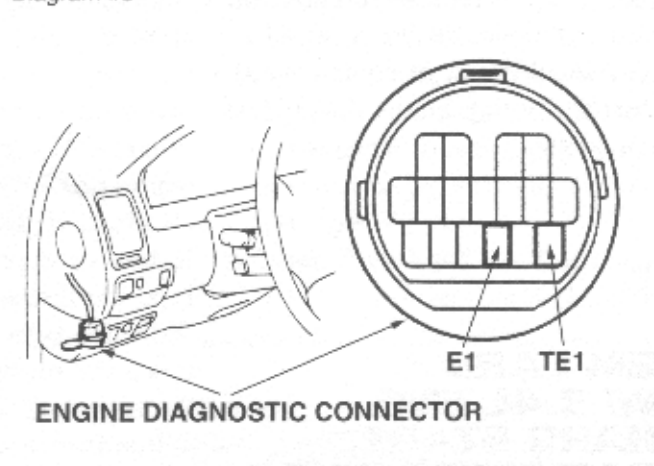
Diagram #5

are equipped with a traction control system. Lexus refers to this system as "TRAC". There is an indicator light on the dash board which shows whether the system is engaged. One of the inputs the "TRAC" system relies upon is the engine speed signal which is supplied from the ECM. If the engine speed signal is not there, or does not look correct, the "TRAC" light will stay illuminated no matter which position the button is in. At this point, the first step is to check for trouble codes in both systems. To check for codes in the engine ECM, place a jumper wire from terminal "TE1" to terminal "E1" of the diagnostic connector under the left side of the dashboard (refer to diagram # 5). Now, turn the ignition key to the "ON" position. At this point, just count the

flashes of the "CHECK ENGINE" light, and record the trouble codes. If you see codes : 12,13,14,15,17, or 18, your timing belt is off at least one tooth. To check for trouble codes in the "TRAC" system, place a jumper wire from terminal "TC" to terminal "E1" of the diag-

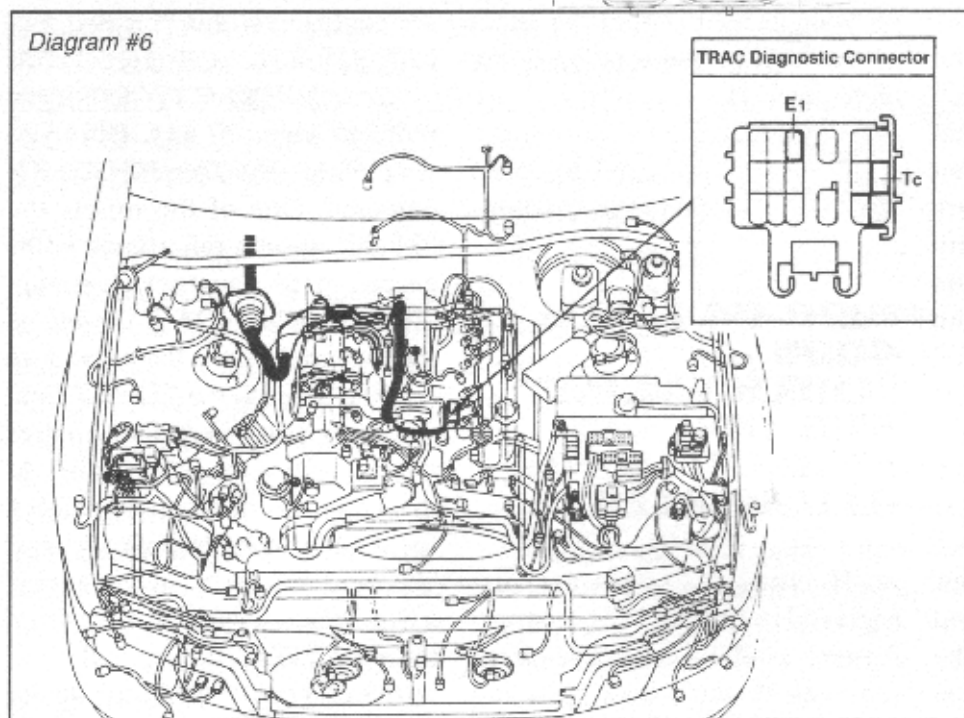
Diagram #6

nostic connector under the hood (refer to diagram # 6). As before, turn the ignition key to the "ON" position and count the flashes of the "TRAC" light. If you discover that any codes are present: 44 or 51 (singularly or in combination), then the timing belt is off at least one tooth.
